## CASE REPORT/CLINICAL TECHNIQUES

# Clinical Management of a Maxillary Lateral Incisor With Vital Pulp and Type 3 Dens Invaginatus: A Case Report

**A maxillary right lateral incisor with a type 3 dens invaginatus and a large periapical lesion with vital pulp in a separate root canal was treated both nonsurgically and surgically. Care was taken not to expose or devitalize the vital pulp in the main root canal system during the treatment. The signs and symptoms ceased after the treatment, and 4-month recall showed complete bone healing with pulp vitality maintained.**

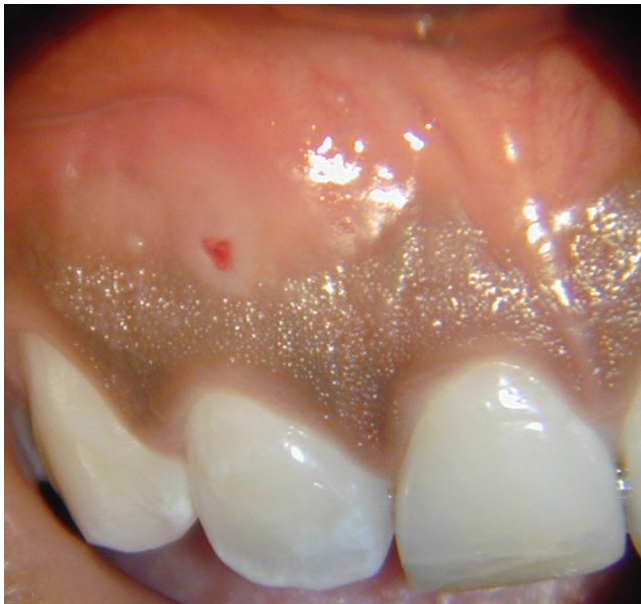
Clinical examination revealed an intraoral sinus tract in the labial gingiva adjacent to the maxillary right lateral incisor (Fig. 1). Clinical tests revealed the maxillary right lateral incisor to be within normal limits to percussion and slightly tender to palpation, with a normal response to cold. The vitality of the pulp was later confirmed with a test cavity. Radiographic examination revealed a 1 × 2 cm radiolucency adjacent to the mesial aspect of the apex of the maxillary right lateral incisor (Fig. 2). The sinus tract was traced with a gutta-percha point to the lesion.

FIG 1. Sinus tract in the buccal aspect of the maxillary right lateral incisor. It was traced to the lesion.

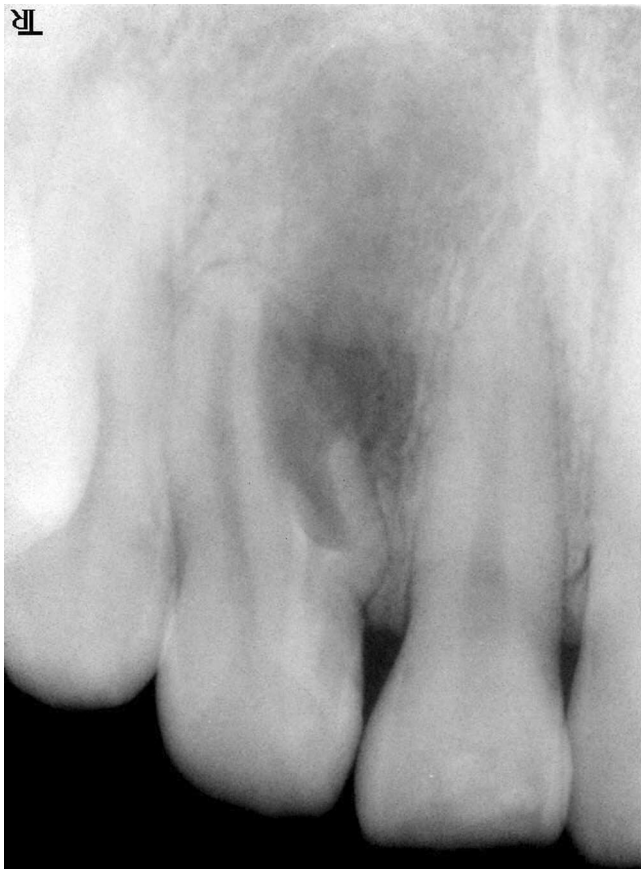
Radiographs revealed an enamel-lined tract, mesial to and separate from the main root canal system, that tracked to the apical radiolucency and appeared to be wide-open at the portal of exit. There was a separate root canal system distal to the dens that appeared to be closed apically. A diagnosis was made of normal pulp with chronic apical periodontitis associated with the type 3 dens invaginatus.

FIG 2. Dens invaginatus lateral incisor with periapical involvement.

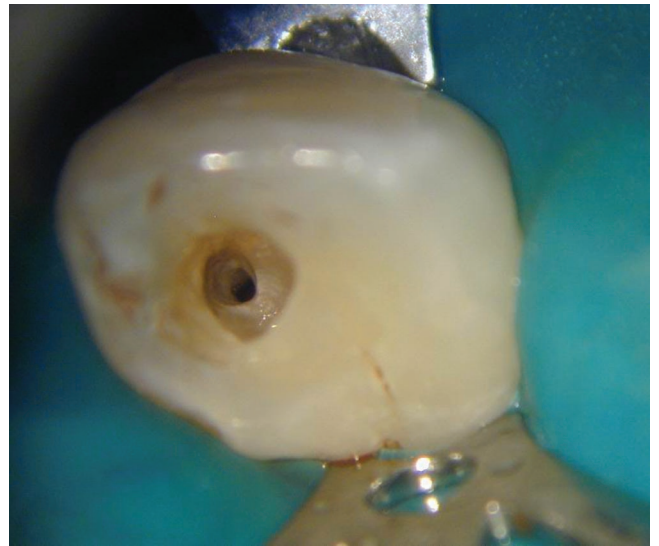
FIG 3. Initial access made in the mesiopalatal aspect of the tooth.

After a test cavity, which confirmed the vitality of pulp, the tooth was anesthetized, and nonsurgical endodontic treatment was initiated. All procedures were performed with the aid of a surgical operating microscope. Of particular interest was the atypical presentation of the lingual surface of the tooth. A rubber dam was placed, and access was made in the mesiolingual aspect of the tooth (Fig. 3). Upon access into the dens, there was a serosanguinous discharge, which was allowed to drain (Fig. 4). The canal was shaped initially with long tapered diamond bur to improve access to the apical defect. Working length of the dens tract was determined with the help of an apex locator (Root Zx, J Morita). The dens was debrided as well as possible with Gates Glidden drills and hand files. Because the canal was lined with enamel, methods for cleaning and shaping were not very effective. Irrigation was performed with 5.25% sodium hypochlorite, 17% EDTA, and 100% alcohol. Calcium hydroxide (Ultracal, Ultradent, UT) was placed in the dens tract between appointments (Fig. 5). The access cavity was sealed with Cavit and IRM between visits to prevent contamination of the dens canal system.

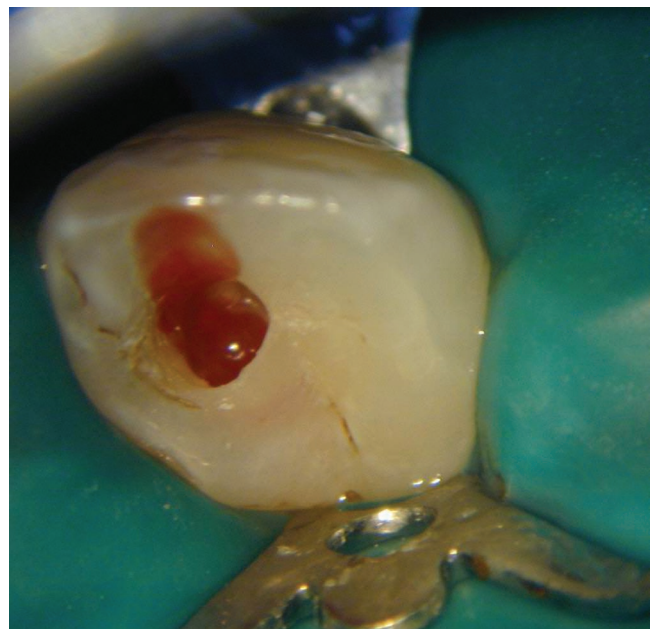
FIG 4. Drainage on access.

At the second appointment, 3 weeks later, the sinus tract was found to be healed. However, there was more serous discharge followed by bleeding through the access cavity after removal of calcium hydroxide paste. After further irrigation, more calcium

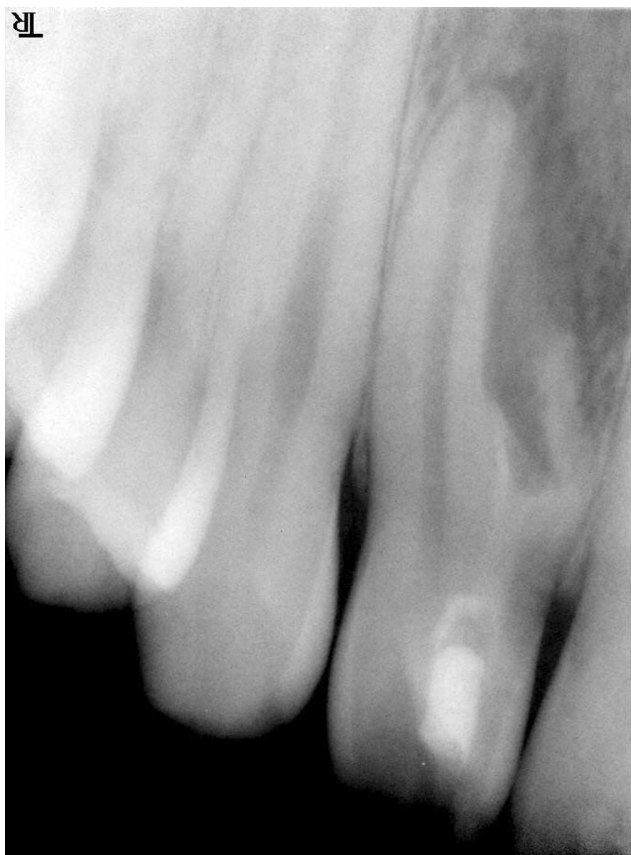
FIG 5. Calcium hydroxide in the canal as interappointment medication. Access sealed with cavite and IRM.

hydroxide was placed in the canal and the patient was asked to return 3 weeks later for completion of nonsurgical endodontic treatment followed by endodontic surgery.

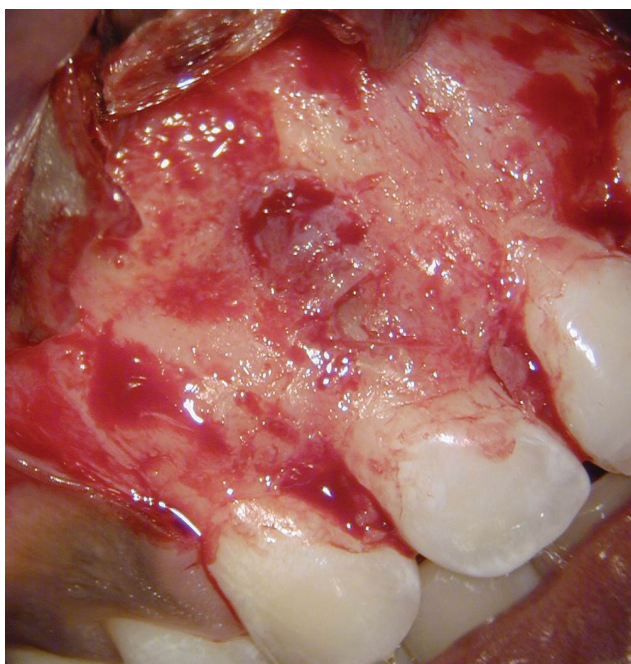
FIG 6. Full thickness flap raised. Notice the large periapical lesion.

At the third appointment, the calcium hydroxide was removed from the canal with irrigation, and there was more drainage. The rubber dam was removed, and a full-thickness flap was reflected to expose the lesion (Fig. 6). The window into the lesion was enlarged, and the soft tissue contents were removed (Fig. 7). Care was exercised not to impinge on the apical area where the root canal system exited. With the help of an air-driven surgical handpiece (Impact Air, Palisade Dental), the apical defect was carefully beveled to improve access to the dens. A large amount of necrotic tissue was found in the apical third of the dens tract. A custom-bent ultrasonic tip (<http://eie2.com>) was used with a Satelac ultrasonic unit to remove the tissue from the apical portion of the dens tract (Fig. 8). Bendable and flexible surgical mirrors ([eie2.com](http://eie2.com)) were

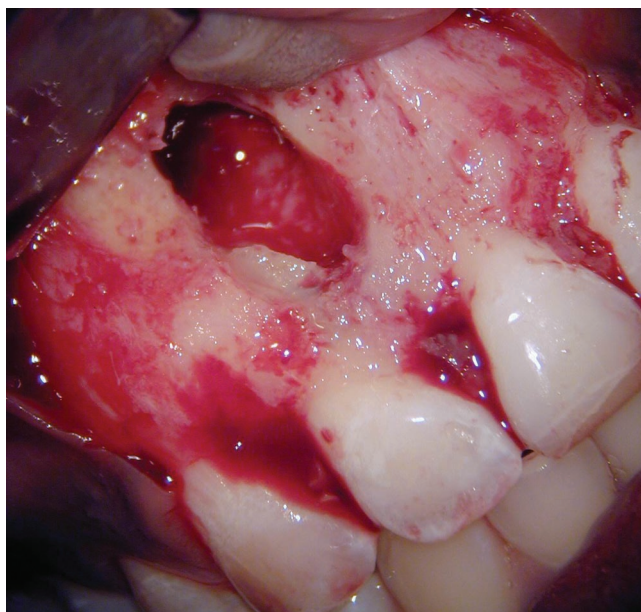
FIG 7. Lesion was curetted. Notice the extent of the bony defect with intact palatal bone.

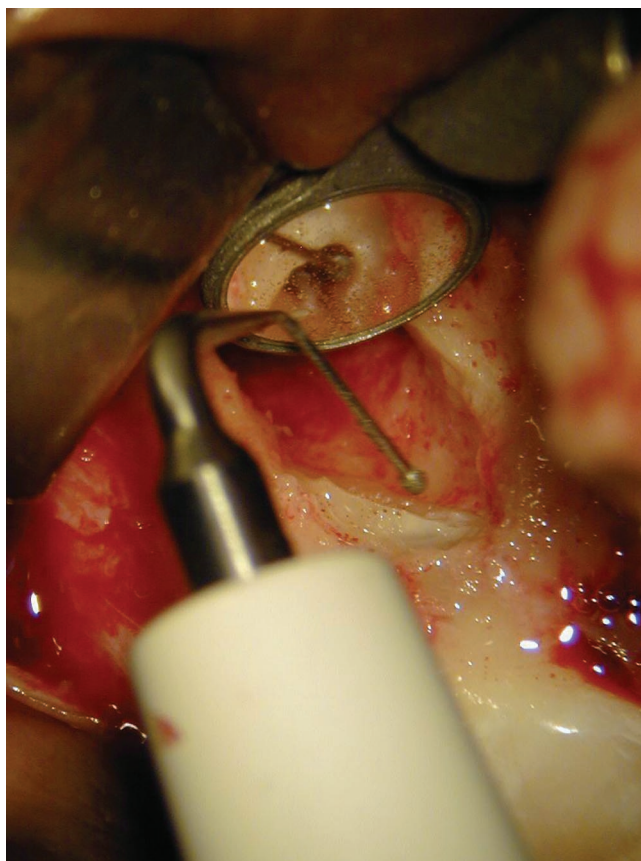
FIG 8. Custom-bent ultrasonic tip used to clean the apical defect of the root.

used for clear vision into the apical defect. With a high vacuum placed at the root end, the dens canal was flushed repeatedly with saline and chlorhexidine gluconate 0.12% (Perioguard) through the

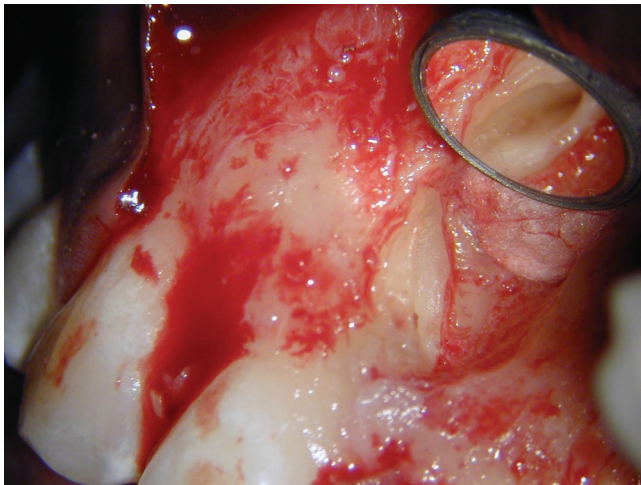
FIG 9. Retro view of the cleaned apical defect through the mirror.

coronal access to clean and disinfect the canal system. Once the canal was devoid of any residual tissue, it was dried with a Stropko irrigator (Vista Dental, Racine, WI) in preparation for the root-end filling and obturation of the remainder of the dens tract (Fig. 9).

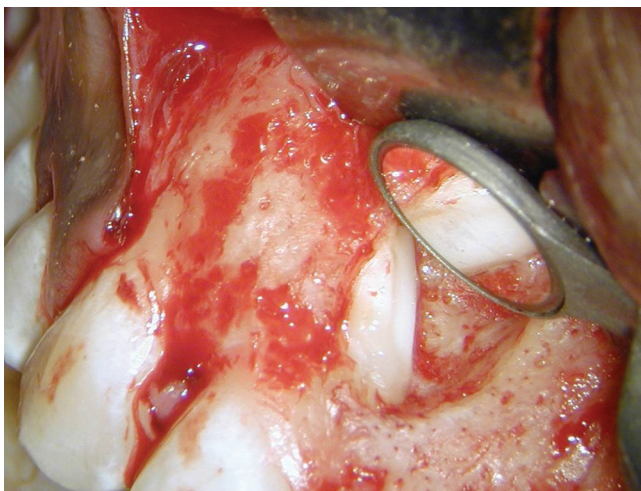
FIG 10. Root-end filling with dual cure dentin bonding agent with filler particles (Optibond).

The root end was etched with 37% phosphoric acid for 10 seconds. A coat of primer (Kerr Corp., Orange, CA) was applied for 10 seconds and air-dried for 10 seconds. A drop of dual-cure activator was mixed with one unit dose of dual cure paste (Optibond, Kerr Corp.), and the mix was teased into the apical defect and light-polymerized (Fig. 10). Because of its dual-cure nature, the composite in the deeper parts of the canal will polymerize even if light penetration is insufficient. A check radiograph verified the flow and dense fill of the root-end filling (Fig. 11). Because the lesion was quite large, medical-grade calcium sulfate was mixed with saline to a thick slurry and placed into the crypt to aid bone healing. The flap was repositioned and secured with 6-0 Tevdek sutures.

Dual-cure Optibond is a dentin bonding agent that contains filler particles. It is, essentially, a lightly filled flowable composite. It was chosen in this case as the root-end filling material for its easy handling characteristics and excellent seal. It also strengthens the thin walls of the root. It can be used only in the presence of excellent hemostasis, however. Andreasen et al. (13) have shown periodontal tissue regeneration including cementogenesis adjacent to retrograde composite fillings.

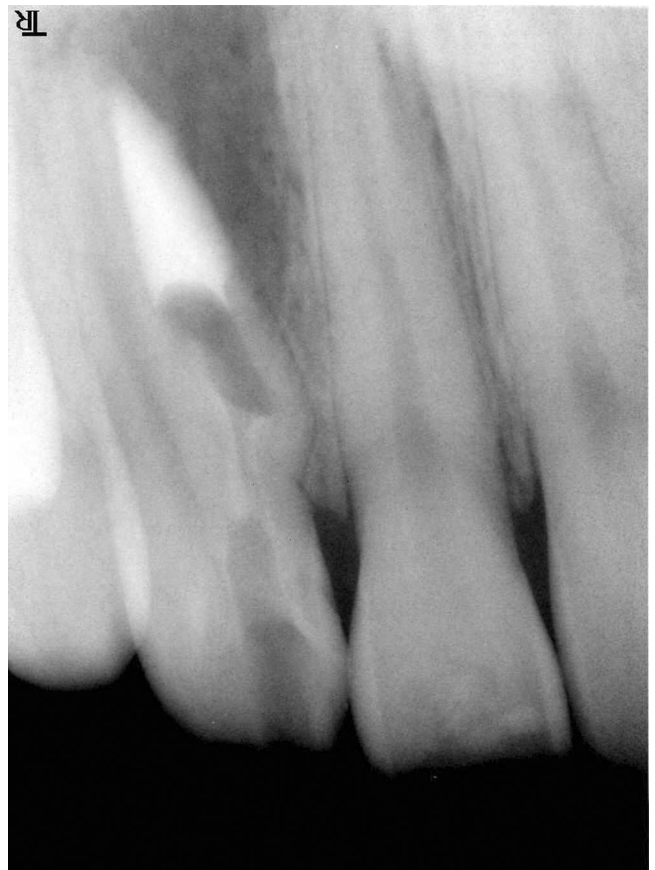
FIG 11. Check radiograph to confirm proper flow and fill of Optibond in the root-end defect.

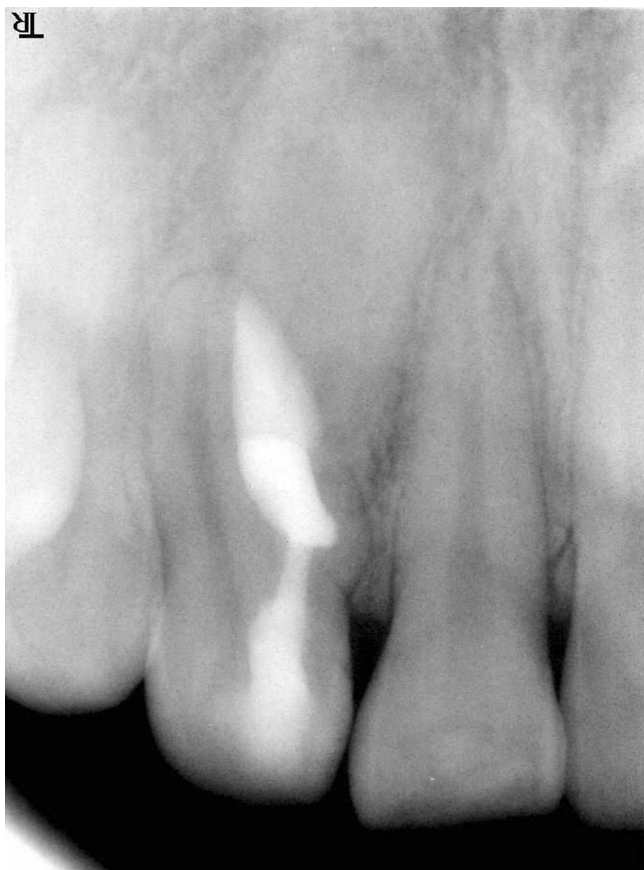
FIG 12. Immediate postoperative radiograph showing obturation of the entire dens canal system. Notice radiopaque calcium sulfate in the bony defect to promote bone regeneration.

The rubber dam was placed back on the tooth, and the remainder of the dens tract was filled orthograde with warm gutta-percha using an Obtura Gun (ObturaII, Fenton, MO) and Kerr pulp canal sealer. The access opening was sealed with a light-cured composite, and a postoperative radiograph was taken (Fig. 12).

Calcium sulfate can be used to aid in hemostasis and crypt control during surgery. It also acts as a soft tissue barrier (14) and has been shown to aid in rapid bone regeneration (15). It is absorbed by the body within a few weeks after it is placed in the crypt. In this case, it was used to aid in complete bone regeneration and to prevent scar formation, because the lesion was quite big.

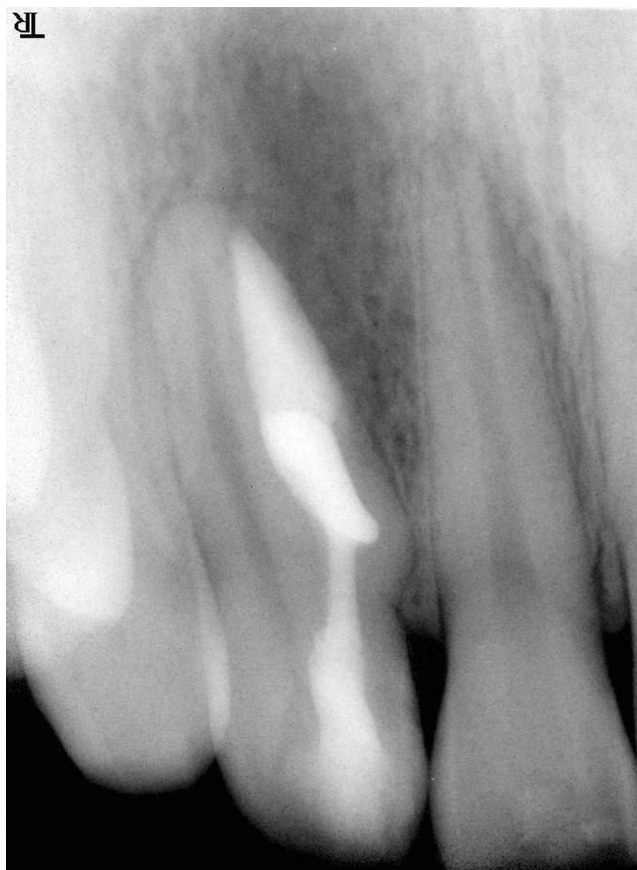
FIG 13. One-month recall showing healing in progress with the resorption of caso4.

normal limits to percussion and palpation at each recall appointment. Radiographs showed rapid healing of the bony defect (Figs. 13, 14, 15). At each appointment, the tooth responded normally to cold.

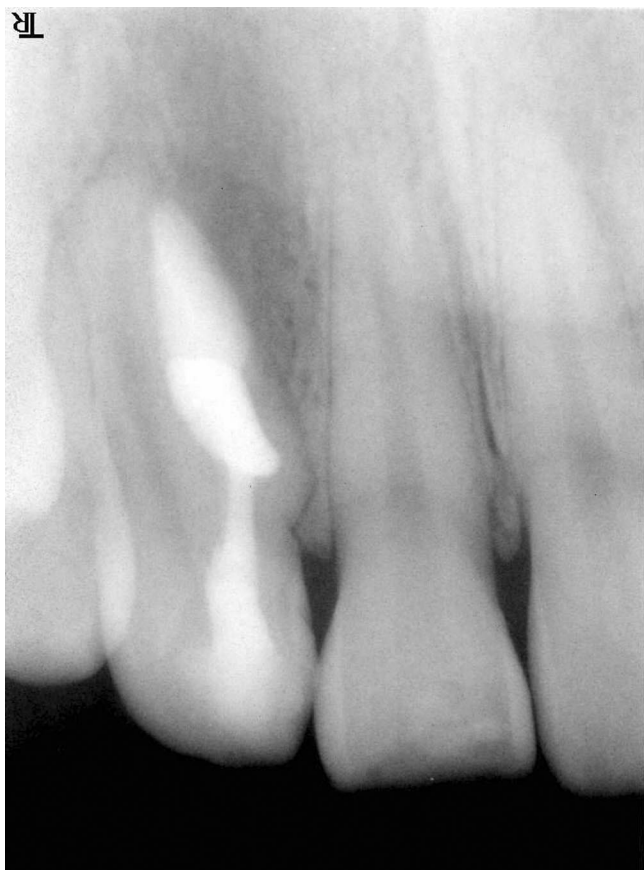
FIG 14. Two months postoperative showing progressive healing.

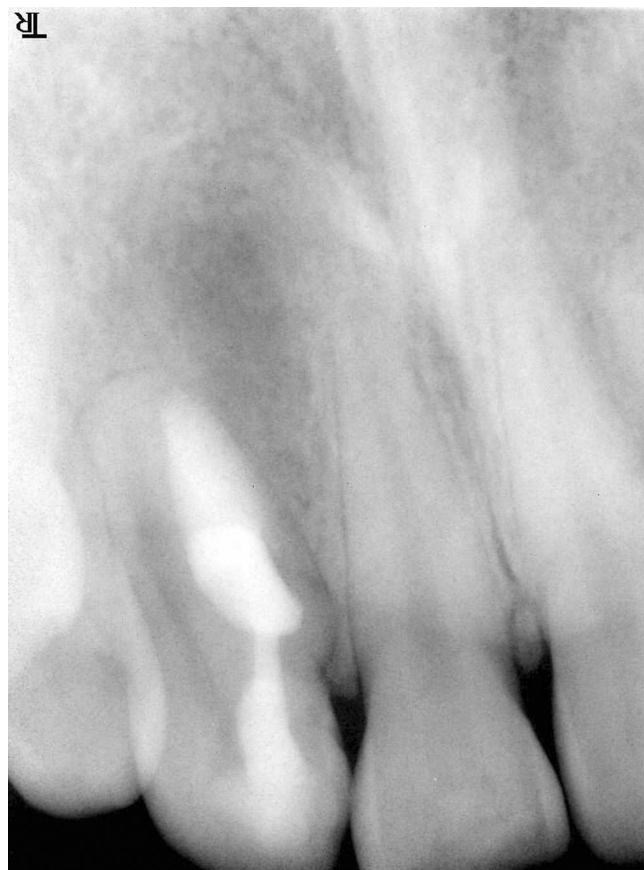
FIG 15. Four-month recall showing excellent healing.
